DEPARTMENT OF TRANSPORTATION

Contract #: 04-0120F4Cty: SF/ALA Rte: 80 PM: 13.2/13.9File #: 1.28**WELDING INSPECTION REPORT****Resident Engineer:** Casey, William**Address:** 333 Burma Road**City:** Oakland, CA 94607**Report No:** WIR-027421**Date Inspected:** 06-Apr-2012**Project Name:** SAS Superstructure**OSM Arrival Time:** 700**Prime Contractor:** American Bridge/Fluor Enterprises, a JV**OSM Departure Time:** 1200**Contractor:** American Bridge/Fluor Enterprises, a JV**Location:** job site**CWI Name:** See below**CWI Present:** Yes No**Inspected CWI report:** Yes No N/A**Rod Oven in Use:** Yes No N/A**Electrode to specification:** Yes No N/A**Weld Procedures Followed:** Yes No N/A**Qualified Welders:** Yes No N/A**Verified Joint Fit-up:** Yes No N/A**Approved Drawings:** Yes No N/A**Approved WPS:** Yes No N/A**Delayed / Cancelled:** Yes No N/A**Bridge No:** 34-0006**Component:** Tower**Summary of Items Observed:**

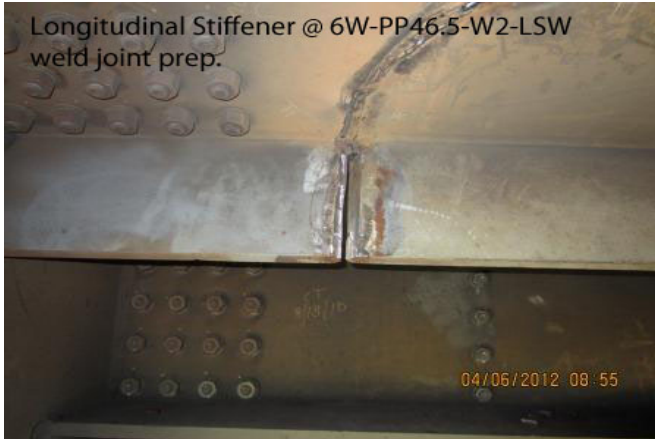
The QA Inspector at random intervals, observed ABF welder Tod Jackson (ID 4639) removing the runoff tabs on longitudinal stiffeners located at 8E-PP70.5-E5-LSE & LSW. The QA Inspector also observed the welder grinding the welds to a smooth finish. The QA Inspector noted the work at this location not completed at this time on this date.

The QA Inspector at random intervals, observed ABF welder Steve Davis (ID 7889) preparing the weld joint utilizing a hand held grinder located at 6W-PP46.5-W2-LSW. The QA Inspector noted the work at this location not completed at this time on this date.

The QA Inspector at random intervals, observed ABF welder Mike Jiminez (ID 4671) preparing the weld joint utilizing a hand held grinder located at DAH-5W-PP36.5-W2-NE. The QA Inspector noted the work at this location not completed at this time on this date.
